# Sonar Bearing vs Reconstructed Bearing

Reconstructed data for Collision between USS GREENEVILLE and EHIME MARU

# Time Range Plot

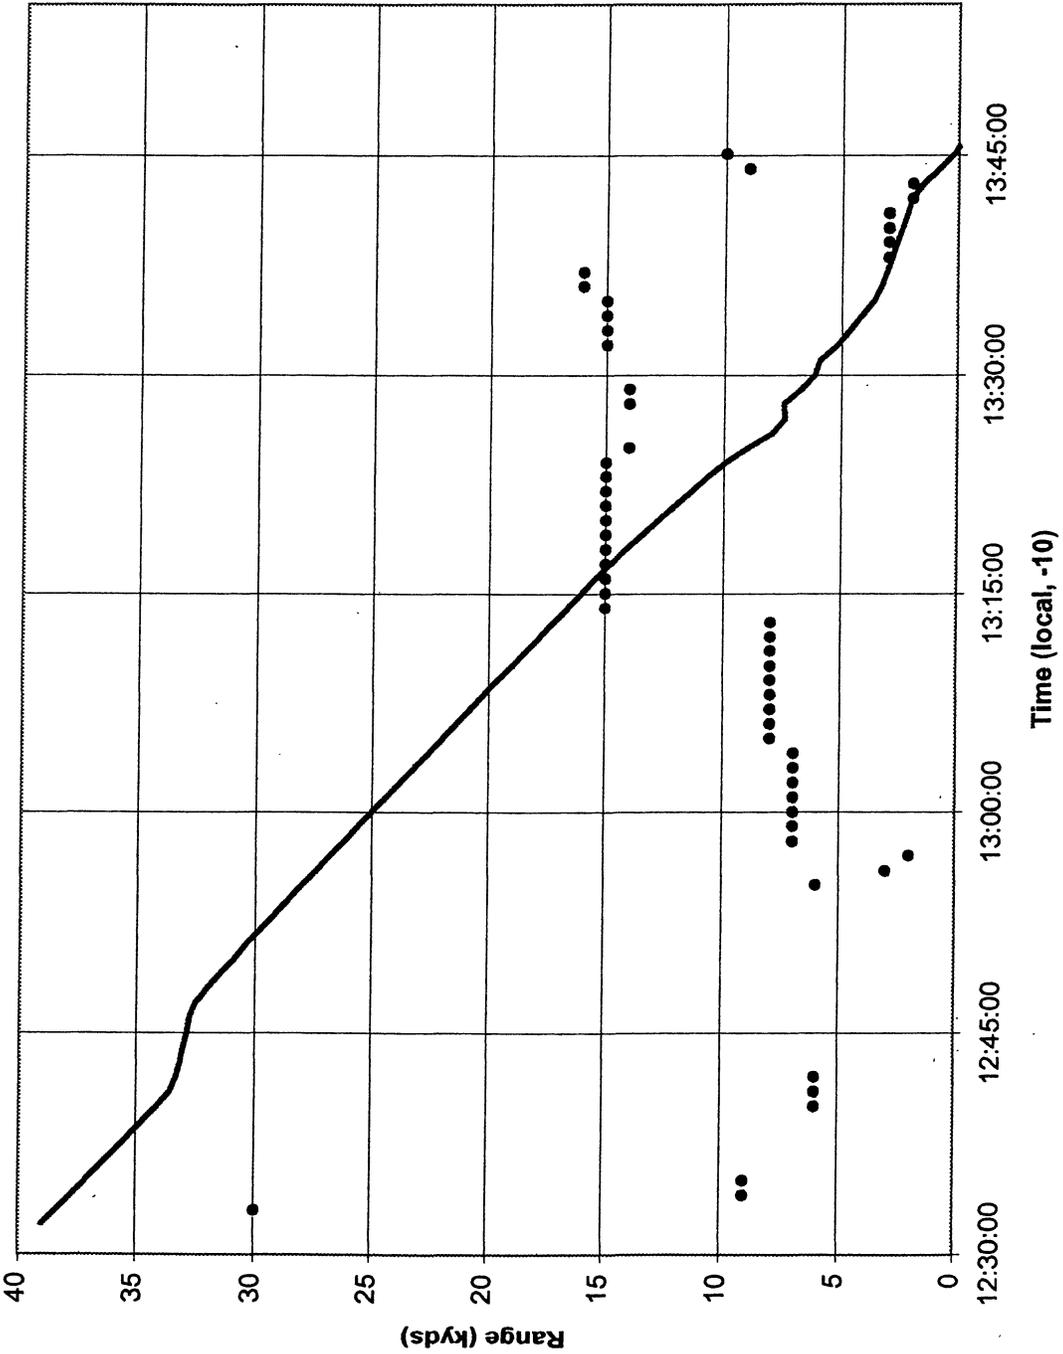
— Reconstructed Range

• FCS Range (S-13 Data from Greenville ARCI Sonar Data Logger)
