DEPARTMENT OF THE NAVY  
COMMANDER NAVAL AIR FORCE  
UNITED STATES PACIFIC FLEET  
BOX 357051  
SAN DIEGO CALIFORNIA 92135-7051

Subj: COMMAND INVESTIGATION INTO THE INCIDENT INVOLVING BACTERIA  
AND OTHER CONTAMINANTS WITHIN THE POTABLE WATER SYSTEM  
ABOARD USS ABRAHAM LINCOLN (CVN 72) ON OR ABOUT 21 SEPTEMBER  
2022

5830  
10 Nov 22

Subj: COMMAND INVESTIGATION INTO THE INCIDENT INVOLVING BACTERIA AND OTHER CONTAMINANTS WITHIN THE POTABLE WATER SYSTEM ABOARD USS ABRAHAM LINCOLN (CVN 72) ON OR ABOUT 21 SEPTEMBER 2022

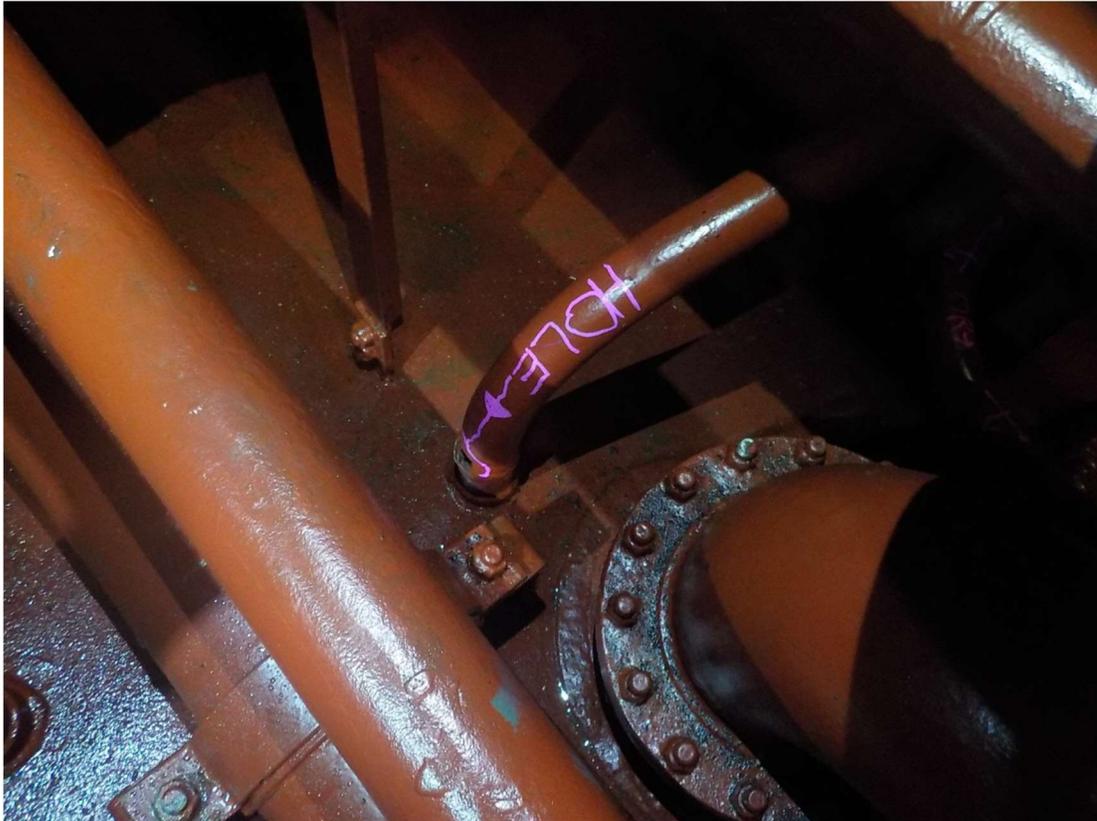
39. On 18 October, PSNS Shop 99 discovered the hole in a vent header of PW Tank (b) (3) (A). [Encl (9)]

40. The vent header hole is approximately 1 inch x 3 inches and about 6 inches above the low point of the bilge in █ MMR. The hole was covered with rotten material and was about 1-inch wide before the final excavation of the pipe. [Encls (9), (25)]

Figure 1: Hole in Vent Header to Tank (b) (3) (A)

1. The primary root cause of LINCOLN's PW system contamination was material. Specifically, bilge water in [REDACTED] MMR was introduced into PW Tank (b) (3) (A) through a hole in its vent header located a few inches above the bilge deck. When bilge levels were high there was a free flow of bilge water into the tank. The regularly occurring seawater, contaminated with oils and greases that collect in the bilge after normal ship operation resulted in the positive bacteriological results and visual indications observed when PW Tank (b) (3) (A) was opened and inspected by PSNS. Once PW Tank (b) (3) (A) was put online, contamination was then able to spread to other parts of the PW System. [FF (1)-(50)]

2. The MP4 Propulsion Plant Piping and Bilge Inspection Program should have been tracking this piping, but wasn't. This vent header was identified as (b) (3) (A) by PSNS. (b) (3) (A)

[REDACTED]  
[REDACTED]  
[REDACTED] Located in the bilge, the (b) (3) (A) vent header was susceptible to corrosion, leading to premature failure in an operational environment with higher
