SUBJ/COMSUBPAC TRAVEL//

## PERISCOPE CONTACT OBSTRUCTION BY SEA STATE

Summary of interview with LT Sloan on 2/14/01

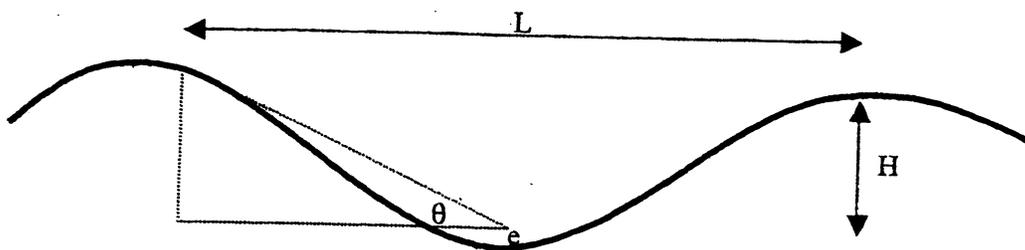
Figure 5. (U) Wave Visual Obstruction

(U) Reviewing from Bowditch, the length from peak to peak of a trough is related to the period of the wave and described by the following equation  $L = 5.12P^2$ , where  $L$  is the length in feet and  $P$  is the period in seconds. The angle below which a visual observation can be obscured by the wave height can be approximated as  $\text{TAN } \theta = (H - e)/2L$ , where  $H$  is the wave height, and  $e$  is the amount of exposed periscope in feet. This is shown graphically in Figure 5.

(U) Consider a typical condition of an observation made from the trough of a 12-foot sea with an 8-second periodicity and 3 feet of scope exposed. The angle of obstruction is about  $3^\circ$ . Under this condition a ship with a 100-foot masthead height could go unobserved until within 700 yards even though our rules of thumb would predict a visual range of greater than 20,000 yards.

(U) Understanding this phenomenon is important and suggests several precautions. Upon arrival at periscope depth, assess wave height (Bowditch has tables for predicting wave height based on sea state observations). The larger the wave height, the greater the potential for obstruction. Remain aware of nominal scope elevation. Periscope operators should understand that if they are maintaining a positive elevation on the scope, they may be looking up at the peak of the wave vice the horizon. Taking an occasional "high look" will also help prevent surface visual contacts from sneaking in due to the reduction in the visual obscuration angle ( $\theta$ ).
